WEST PLANT AREA

RCRA CORRECTIVE ACTION / CERCLA REMOVAL ACTION
BEDFORD FACILITY
BEDFORD, INDIANA

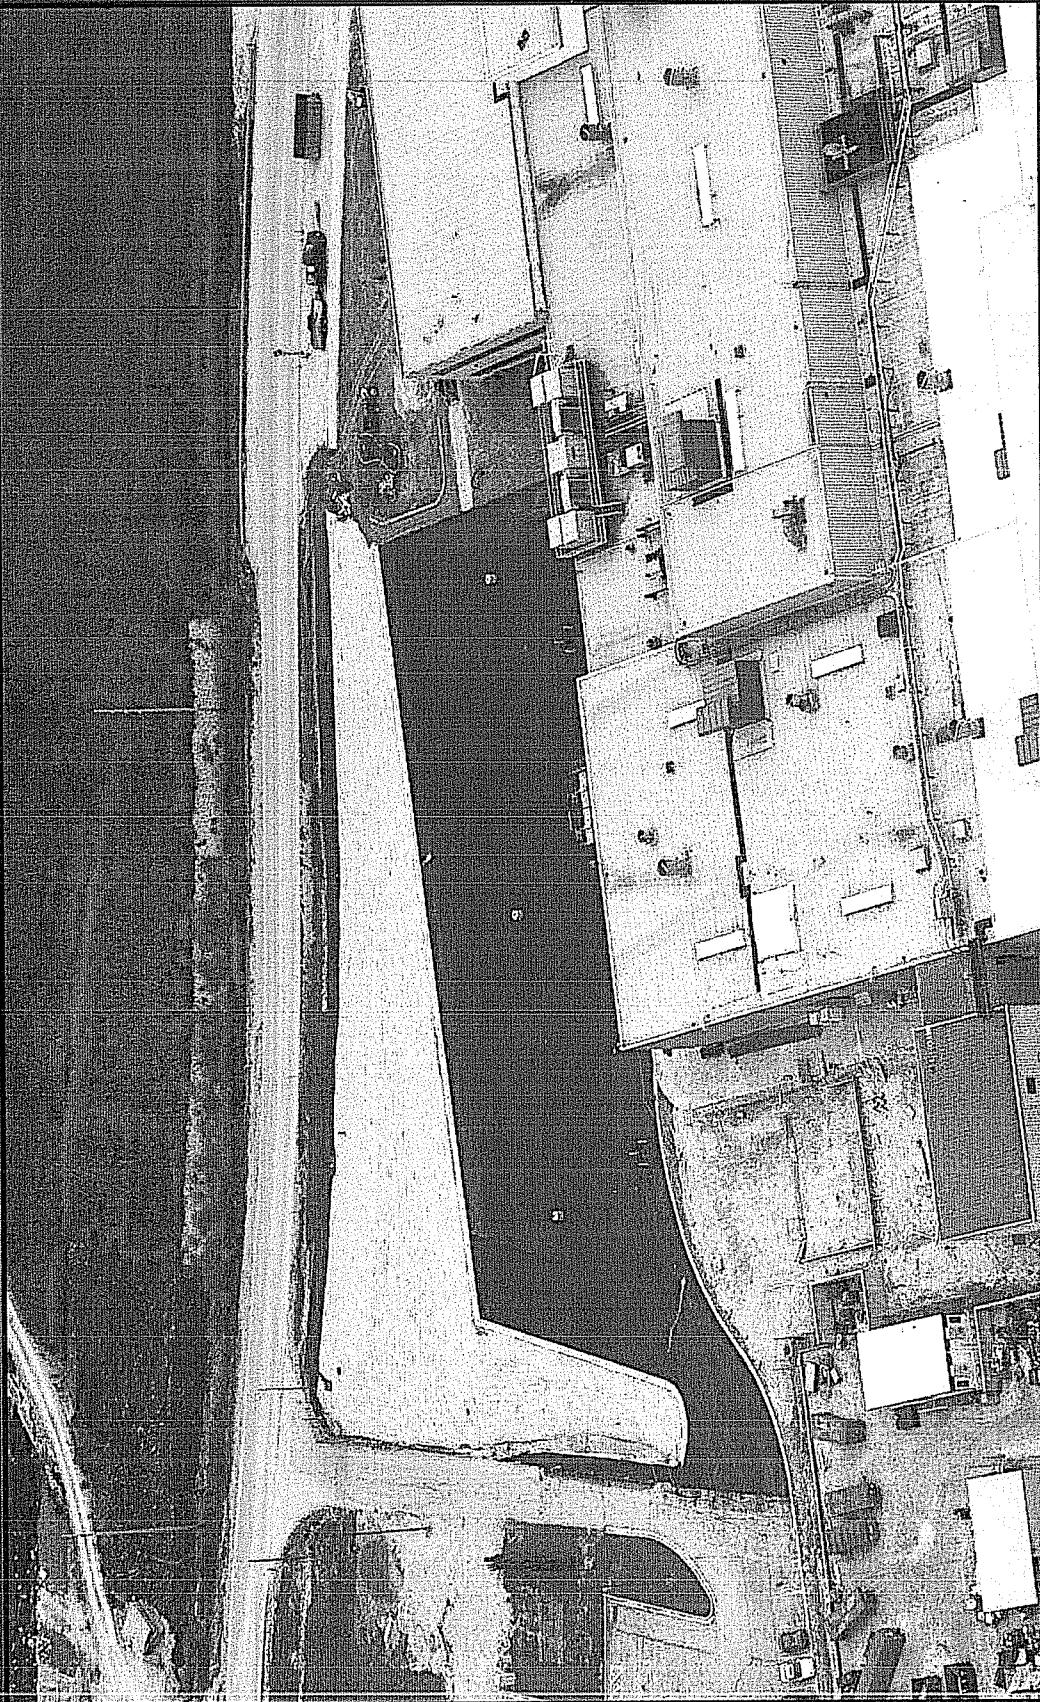
- Construction of the permanent vegetative and asphalt cover placed over the former excavation resumed in June 2011.
- Asphalt cover completed in August 2011.

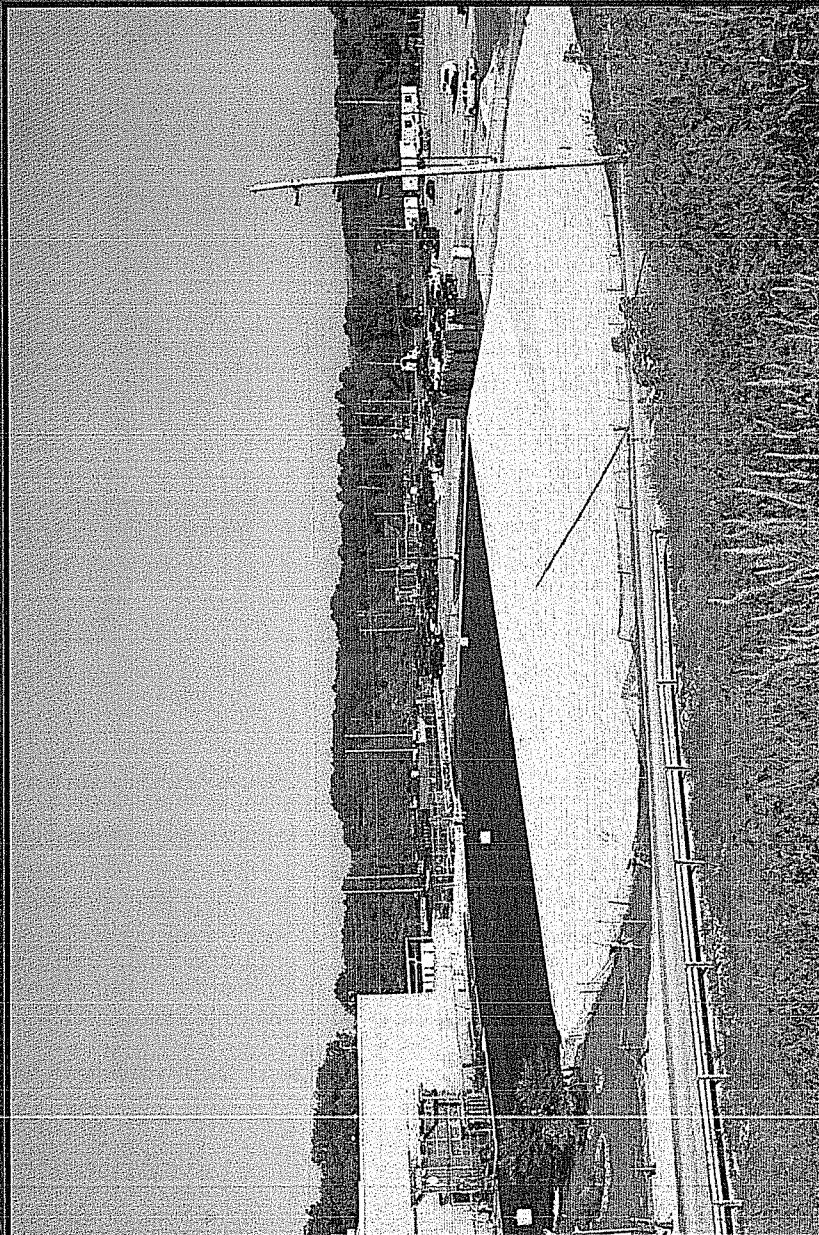
- Additional sampling completed in August 2011 the "front lawn" area of the plant.
- Additional excavation completed in the West Plant Area.
- Excavation depth ranged between 1 and 1.5 feet below ground surface.
- Excavation and backfill completed in August 2011.

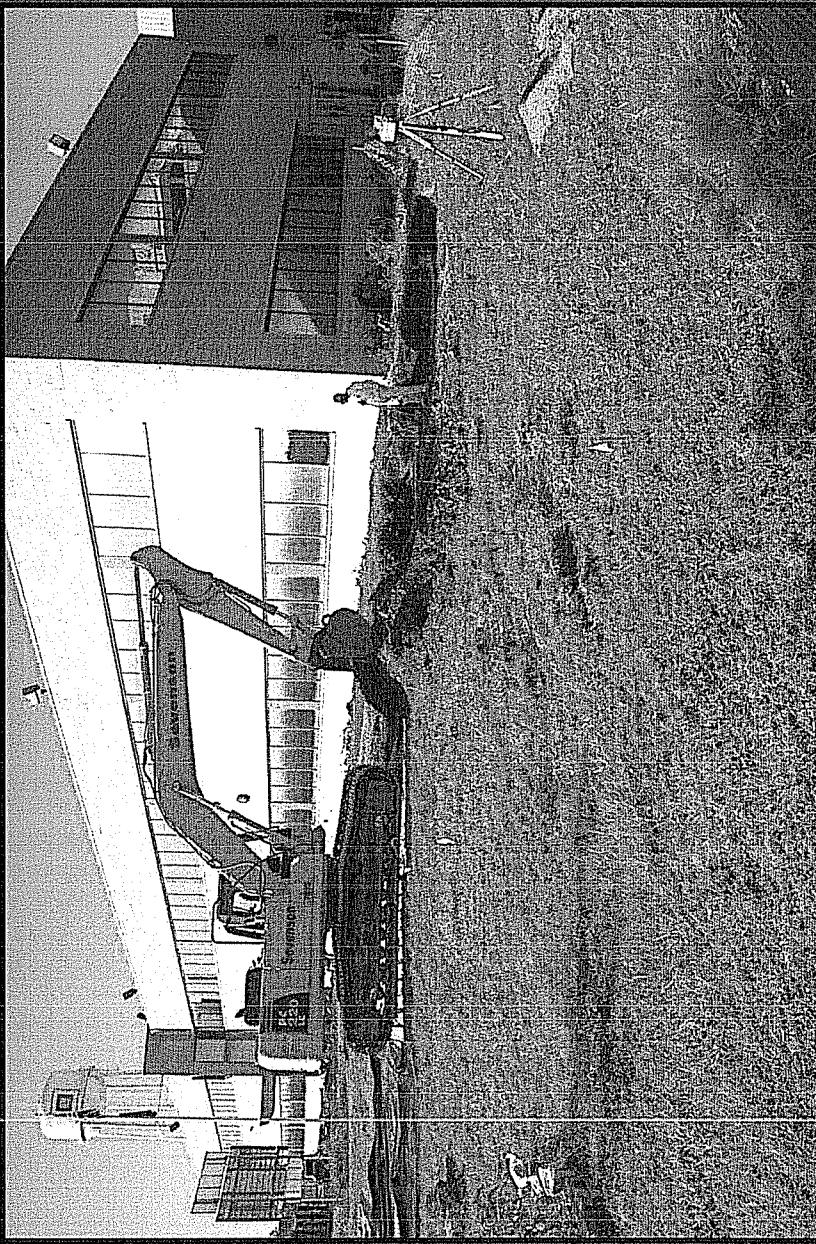
- Packer testing on existing wells with oil as part of additional bedrock studies completed in the spring of 2011 at AOI 8
- Vertical oil delineation testing at 2 wells southeast of the facility started in March 2011
- Packer testing confirmed the location of fractures containing oil.
- Following review of collected data, an oil recovery system will be designed and constructed in 2011/2012
